FATAL ACCIDENT INVESTIGATION REPORT

Isomerization Unit Explosion Final Report

Texas City, Texas, USA

Date of Incident: March 23, 2005
Date of Report: December 9th 2005

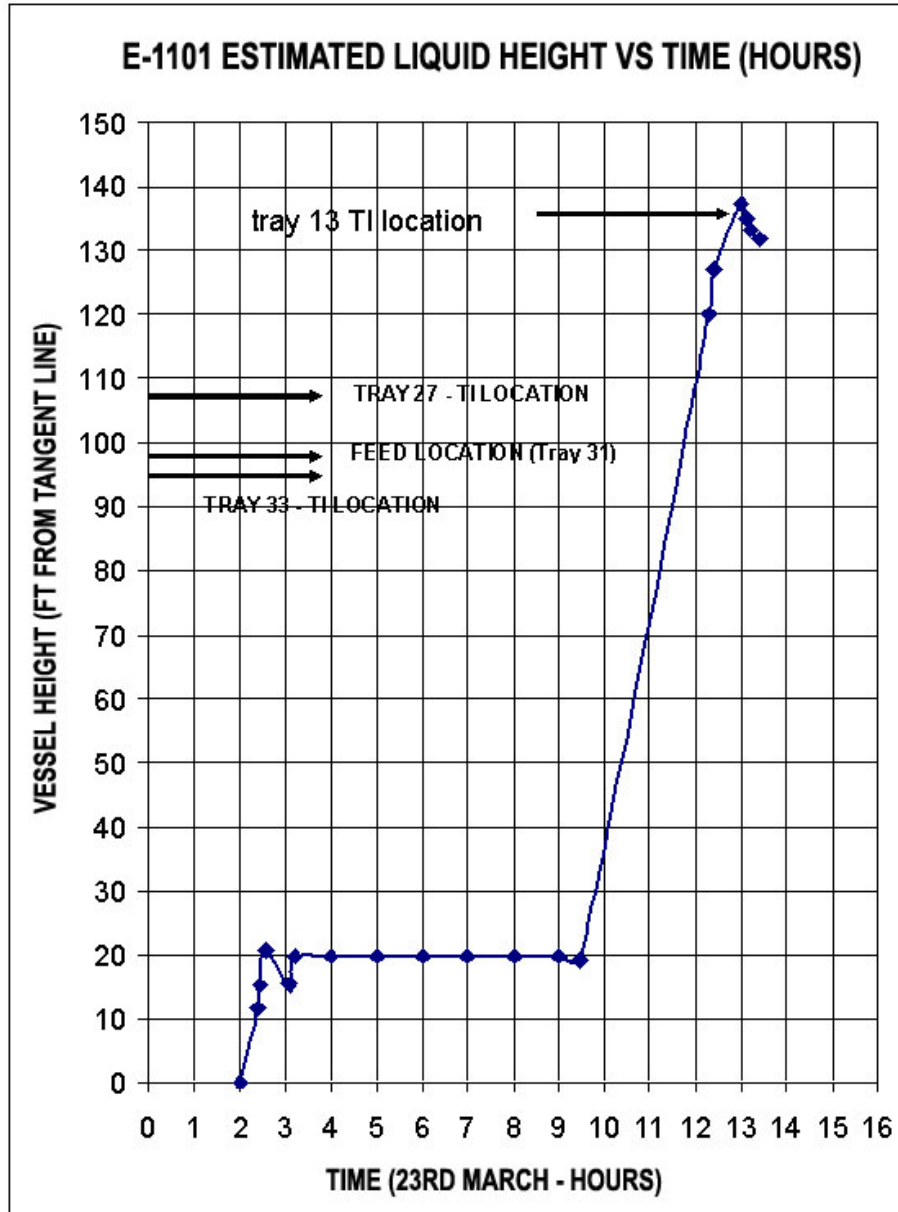
**Figure 5-1
Raffinate Splitter Estimated Liquid Height vs. Time**

A mass balance based upon DCS data performed by integrating the Splitter flow meters into and out of the column over the startup period indicates that the vessel was substantially overfilled. During the night shift, the column was initially overfilled to greater than 100 % of the base level range. When the main startup recommenced at 09:52 hrs, the feed rate was increased to approximately 20 MBPD and was held at this rate for a period of almost 4 hours. There was no bottoms offtake from the column until 13:00 hrs, (possibly due to a closed block valve). A summary of the accumulation of liquid in the vessel, shown in Figure 5-1 below, indicates that the calculated liquid level peaked at tray 13. This makes no allowance for vaporization and expansion of the liquid within the vessel, as the contents partly vaporize in the base of the tower. These are discussed in more detail in the dynamic modeling section below. The estimated liquid level was confirmed when the Splitter was deinventoried.

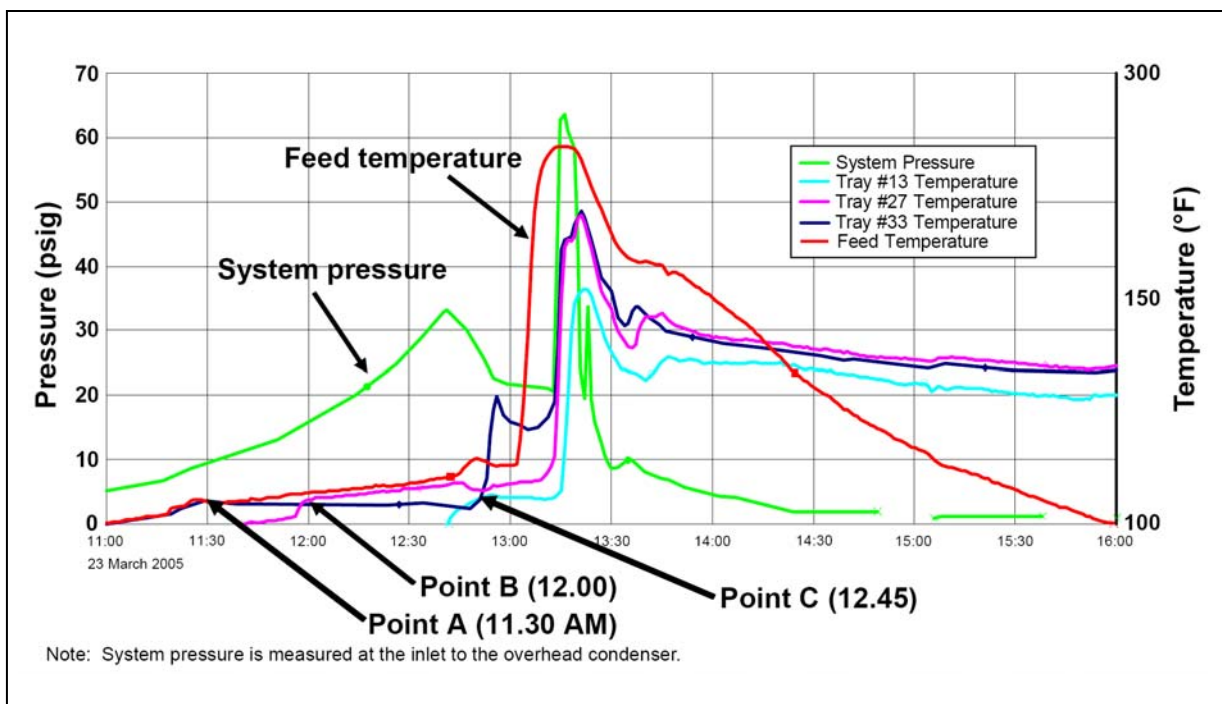
Figure 5-2
Raffinate Splitter Tower Temperatures as Level Rises

Inside the column, there are temperature indicators (TIs), just below trays 13, tray 27, tray 33, tray 48 and tray 59 (located in the downcomers) with readings visible to the board operator and recorded on the DCS. These further confirm that the column was substantially overfilled with liquid during the startup period between 9:52 hrs and the rapid pressure increase at 13:13 hrs. The feed temperature into the column (T-5005) gradually warmed up from a temperature of 80°F at 10:00 hrs to 126°F at 13:00 hrs. When one compares the feed temperature (red line) with these column TIs, the point at which these temperatures cross (or diverge) indicates the level in the column at that particular time, as illustrated in Figure 5-2:

When the heavy raffinate rundown was opened, there was a rapid increase in the feed temperature from 126°F to 260°F in less than 10 minutes. This abnormal heat addition at feed tray 31 caused a rapid onset of vaporization to occur, which led to the liquid above the feed tray being lifted to the top of the tower and into the overhead line. Given the pressure at the feed tray (including liquid head above it), the feed would have started to vaporize at about 255°F.

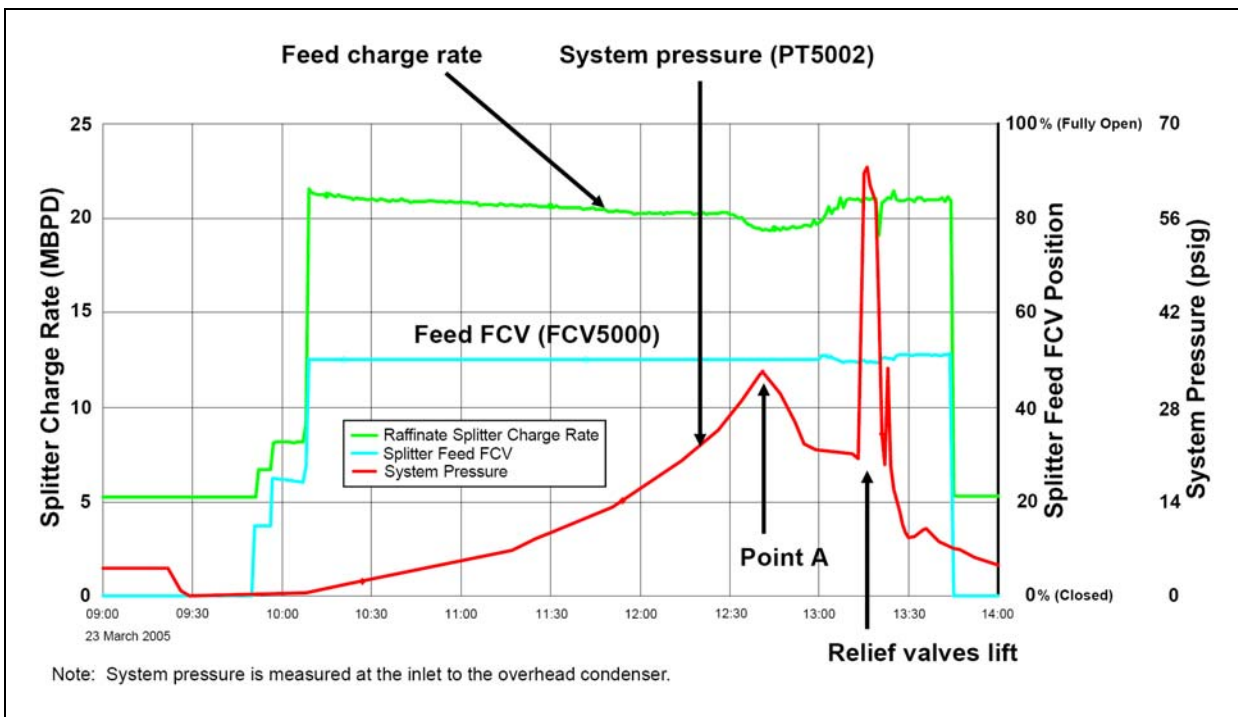
**Figure 5-3
Decline in Feed Flow Rate as Splitter Pressure Rises**

Analysis of the characteristics of the feed charge flow meter (F-5000) shows that the feed rate into the unit varies depending upon the Splitter static pressure. The feed pump is a centrifugal pump with a typical flow vs. head curve. The feed flow control valve (FCV-5000) was on manual up to 13:01 hrs, and as the pump backpressure increases, so the inlet flow rate falls. This is shown in Figure 5-3:

These data show that the feed inlet rate generally responds to the column backpressure. As the column pressure builds (as the column is overfilled) so the feed inlet rate falls gradually. As the column is manually depressurized (point A), the feed rate then increases.

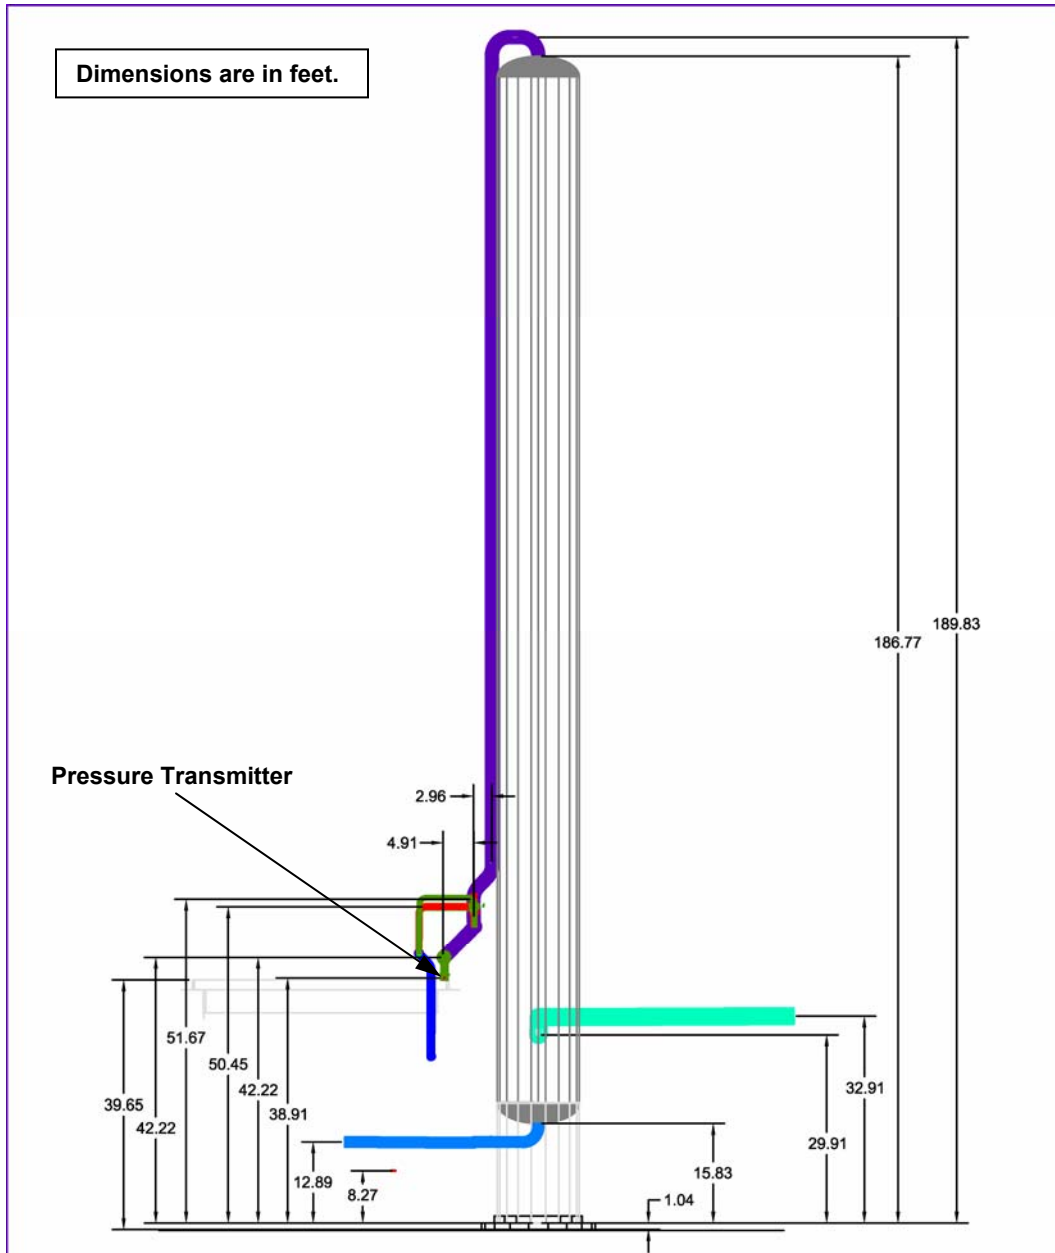
Figure 5-4
Raffinate Splitter Tower Elevation

The column pressure transmitter (PT-5002) and relief valves are located adjacent to the overhead condenser fin-fan inlets approximately 150 ft below the top of the column.

The only way that the pressure transmitter would indicate a higher pressure than the column pressure (as inferred from the feed pump) is due to the hydrostatic head in the overhead line—up to 150 ft of liquid. The fluid density is approximately 41.4 lbs/cu ft, so this head creates a pressure of up to 42.4 psi. The column pressure just before the rapid increase in system pressure was 21 psig. When these two figures are added (63.4 psig), this closely agrees with the maximum pressure observed from the PI data (for PT-5002).

This suggests that the overhead 24-inch vapor line to the condenser was filled with liquid, which had been lifted up and over into the overhead line by vaporization of the feed and the reboiler return/tower bottoms lifting the extremely high liquid level in the tower. The sample analysis of the liquid in the reflux drum (see Appendix 11) confirms that feedstock had been carried overhead. The relatively high hydrostatic head coupled with a static column pressure of 21 psig was easily sufficient to lift the relief valves (also located at a similar elevation to the fin fans). Since the pressure spike is due to a high hydrostatic liquid head, then the pressure relief valves pass largely 100% of sub-cooled liquid (see section 5.3.3 below).

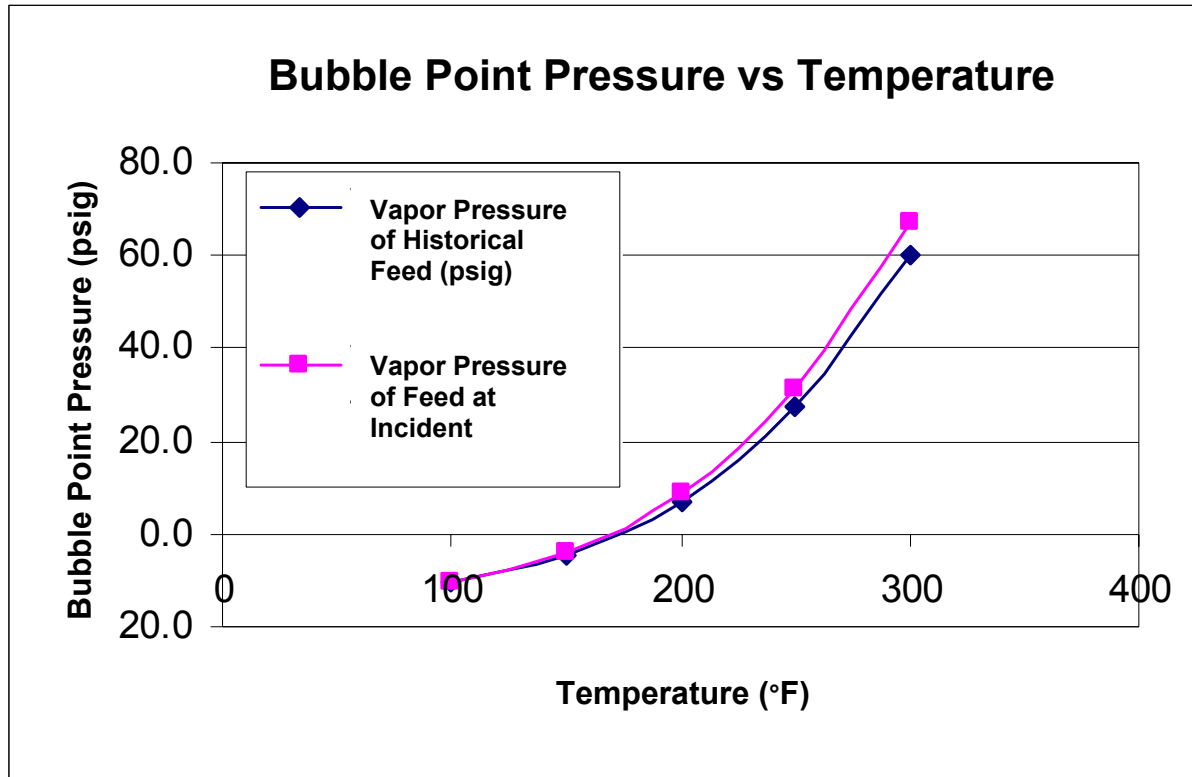
Figure 5-5
Bubble Point Pressure vs. Temperature

Analysis of the feed composition to the unit (Appendix 11) was compared with historical data. There were no significant abnormalities regarding the feed composition to the unit on the day of the incident. The corresponding bubble point pressure predictions for the unit feed are shown below compared with a historical data set in Figure 5-5.

These vapor pressure calculations confirm that the historical feed analyses and the analyses of March 23 are quite similar.

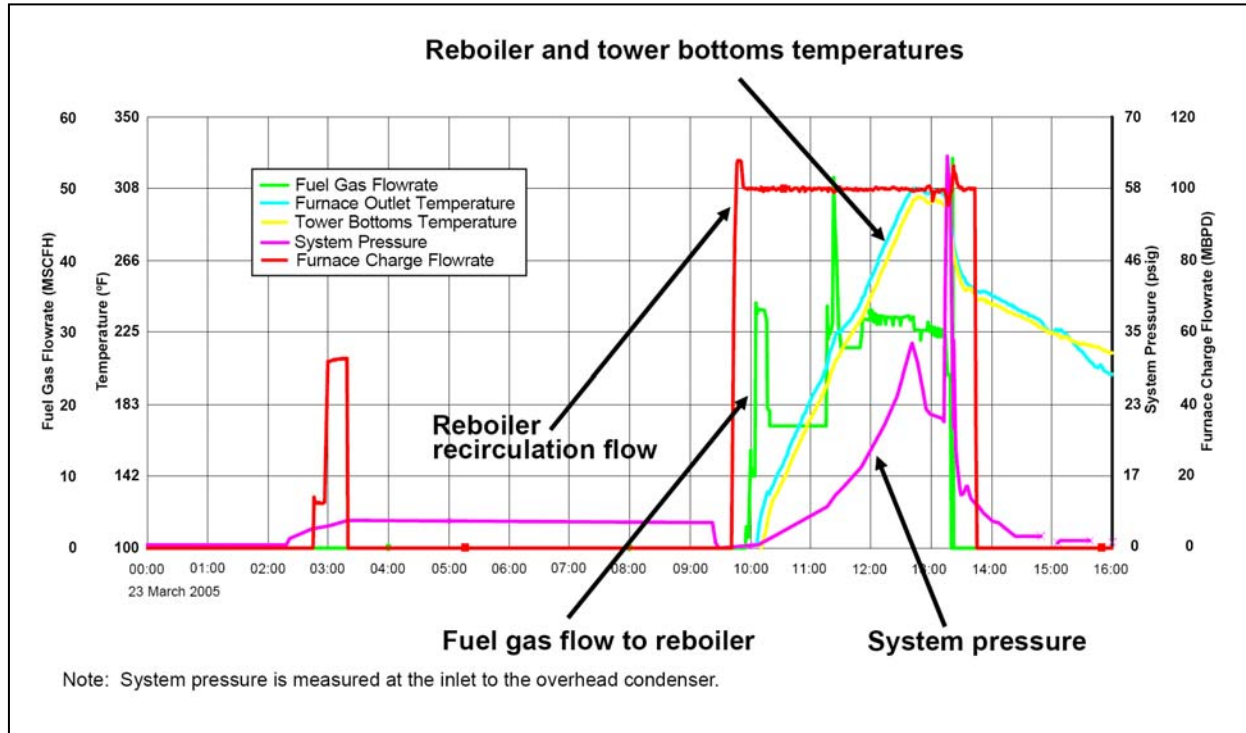
Figure 5-6
Reboiler Fuel Gas Flow Rate During Incident

The Raffinate Splitter reboiler is a recirculating fired heater. The circulation rate during the startup was approximately 100 MBPD, and the differential temperature between the reboiler outlet and the column outlet was around 10°F. A summary of the reboiler fuel gas flows (green line) during the startup are shown below in Figure 5-6:

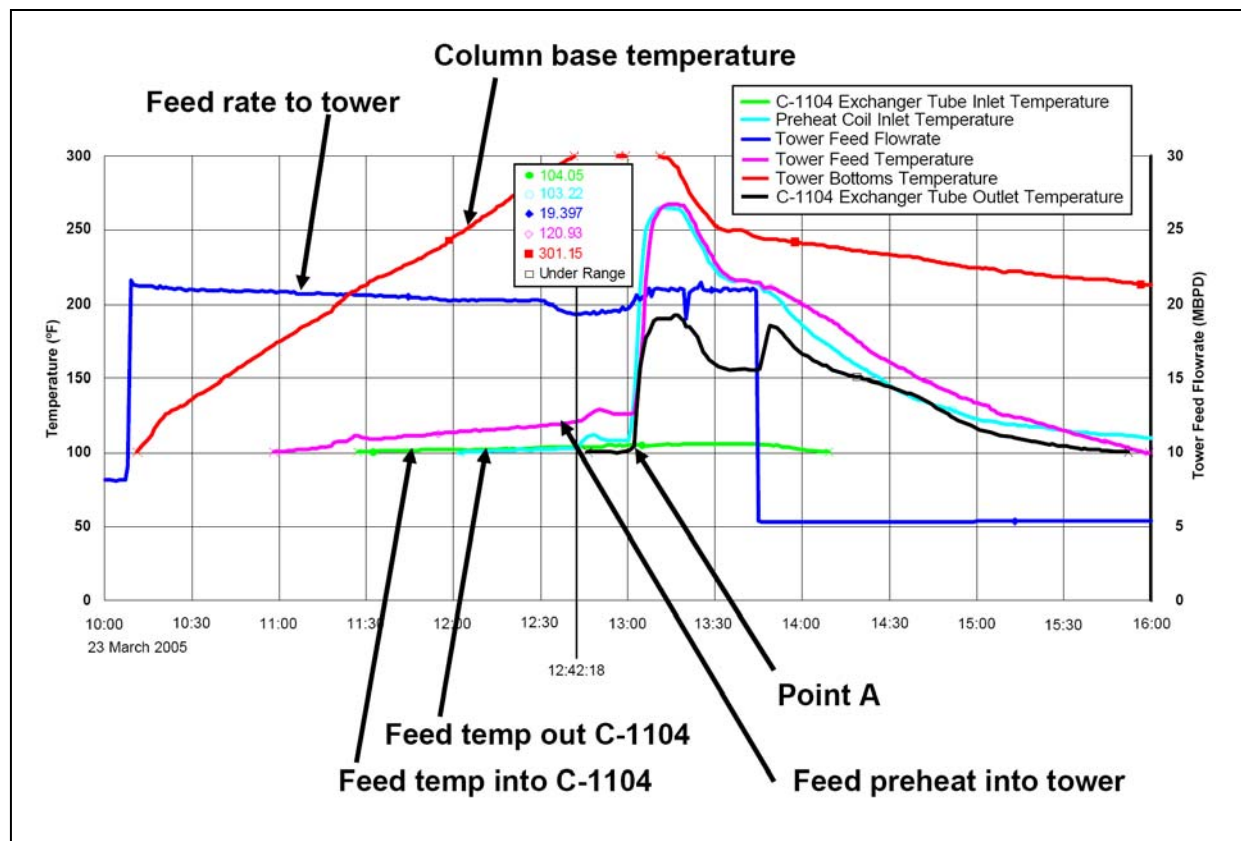
**Figure 5-7
Feed/Effluent Heat Exchange**

The heat balance across the feed/effluent exchangers (C-1104A/B) indicates that up until the time at Point A (at 13:00 hrs), there is no differential temperature across the tube side (feed). For the shell side (heavy raffinate), the shell effluent temperature is under range (less than 100°F). This is not surprising since the heavy raffinate level control valve (LCV-5100) was in the closed position (i.e., no flow through the shell side). At Point A, the heavy raffinate LCV is open, and the heavy raffinate flow increases rapidly to approximately 31 MBPD. This has a dramatic effect on the feed preheat increasing across the feed/effluent exchangers from 126°F to 267°F between 13:00 to 13:10 hrs. This is equivalent to a preheat energy transfer of about 18.6 mmBTU/hr (assuming no phase change). The corresponding transfer from the heavy raffinate shell side is around 17 mmBTU/hr (based on a differential temperature of 302°F to 191°F and a flow average of 24 MBPD).

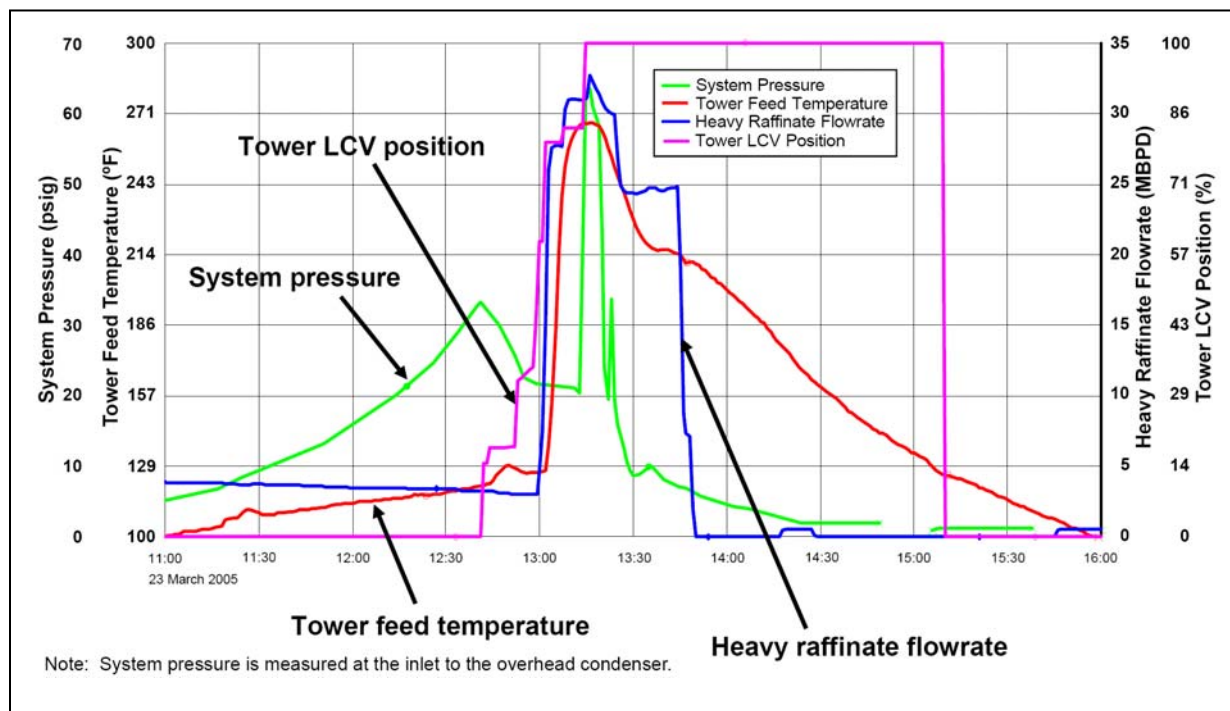
**Figure 5-8
Feed Preheat to Raffinate Splitter Tower**

As noted previously, the feed preheat to the Splitter increased dramatically once the Heavy Raffinate bottoms flow was opened. Between the period 13:00 to 13:10 hrs, the feed preheat increased from 126°F to 267°F (Figure 5-8).

The estimated pressure at the feed location (tray 31) is the column operating pressure plus the hydrostatic head of liquid at that point. From discussion above, the liquid level at this time is believed to have been at tray 13—approximately 41 ft above the feed location. The column pressure (from PT-5002) at this time was 21.5 psig, so the feed pressure is calculated as 33.1 psig. Based on the feed composition, it is estimated that the feed quality at 33.1 psig and 267°F is approximately 14.9 mole % (14.1 wt %) vapor.

Despite some vapor being quenched by the relatively cold hydrocarbon liquid above, the quantity was sufficient to lift the liquid up and over into the overhead line. The absence of any tray damage, when the tower was inspected after the incident, indicates that this sequence of events was a gradual steady effect sustained for six minutes and not a sudden one.

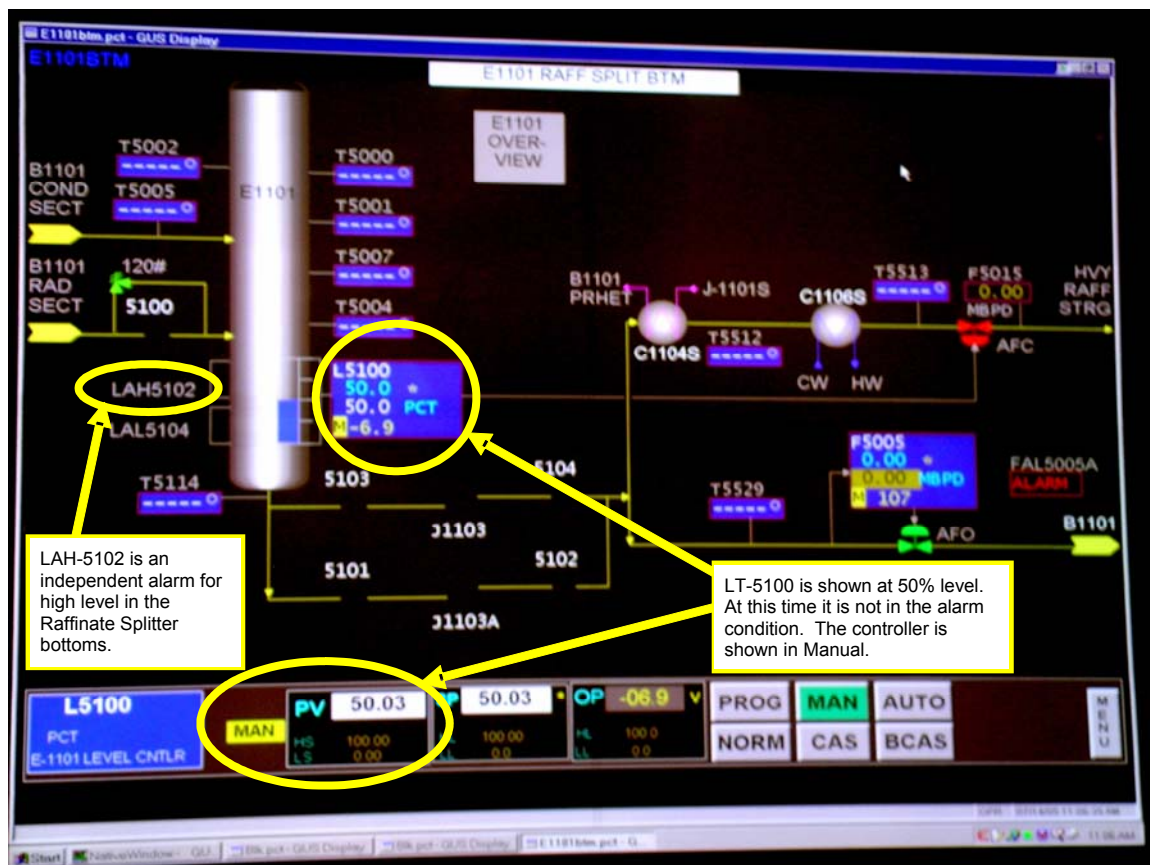
The Raffinate Splitter level indicator (LT-5100) is a displacer type device and worked as designed, providing accurate readings of liquid levels in the tower until it was filled over the design control range. Figure 5-9 shows the level indication on the control board screen.

DCS Screen Showing Raffinate Splitter Level Not in Alarm at 50% Level

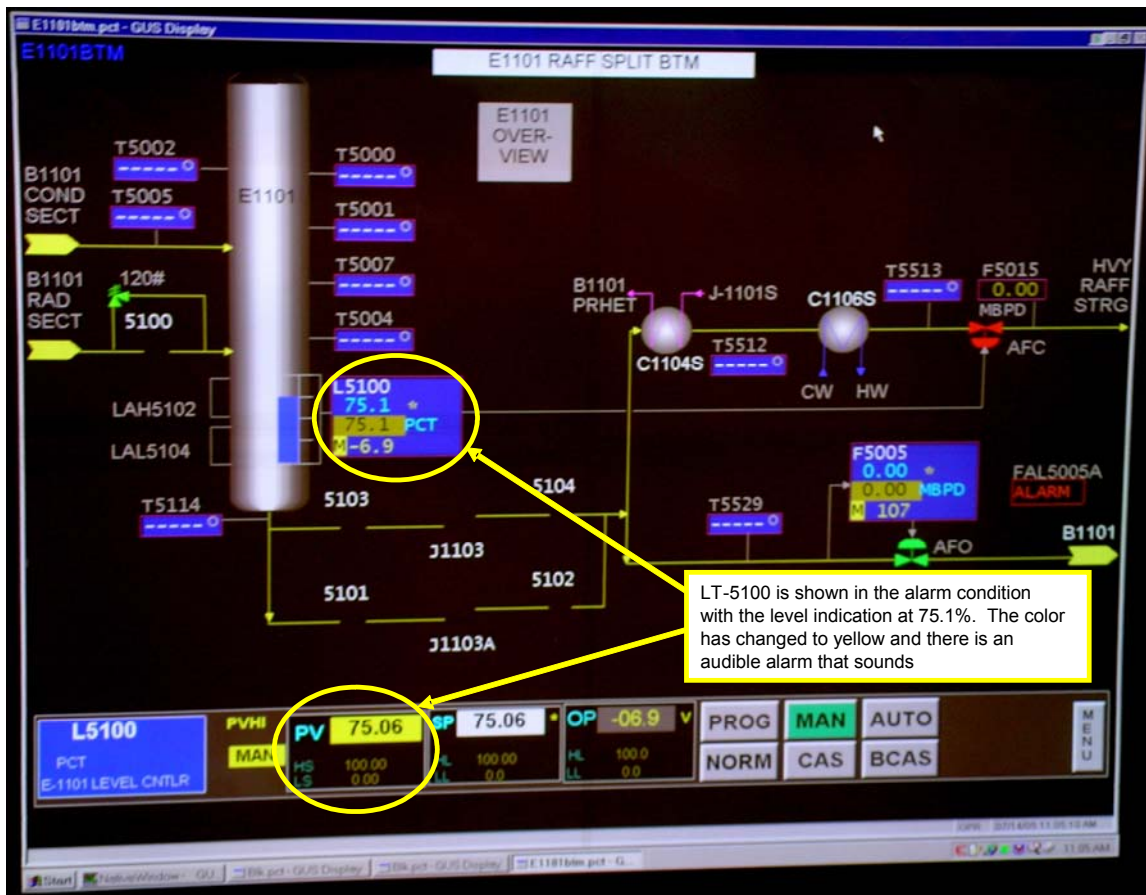
The high level alarm from the distributed control system (DCS) level controller (LT-5100), which was set to sound when the level reached 72%, worked as designed. The alarm sounded and was acknowledged at approximately 03:00 hrs March 23. The alarm indication remained on throughout the subsequent startup and only cleared during deinventorying of the tower. Figure 5-10 shows the control board screen with the level transmitter in alarm.

DCS Screen Showing Raffinate Splitter Level in Alarm at 75% Level

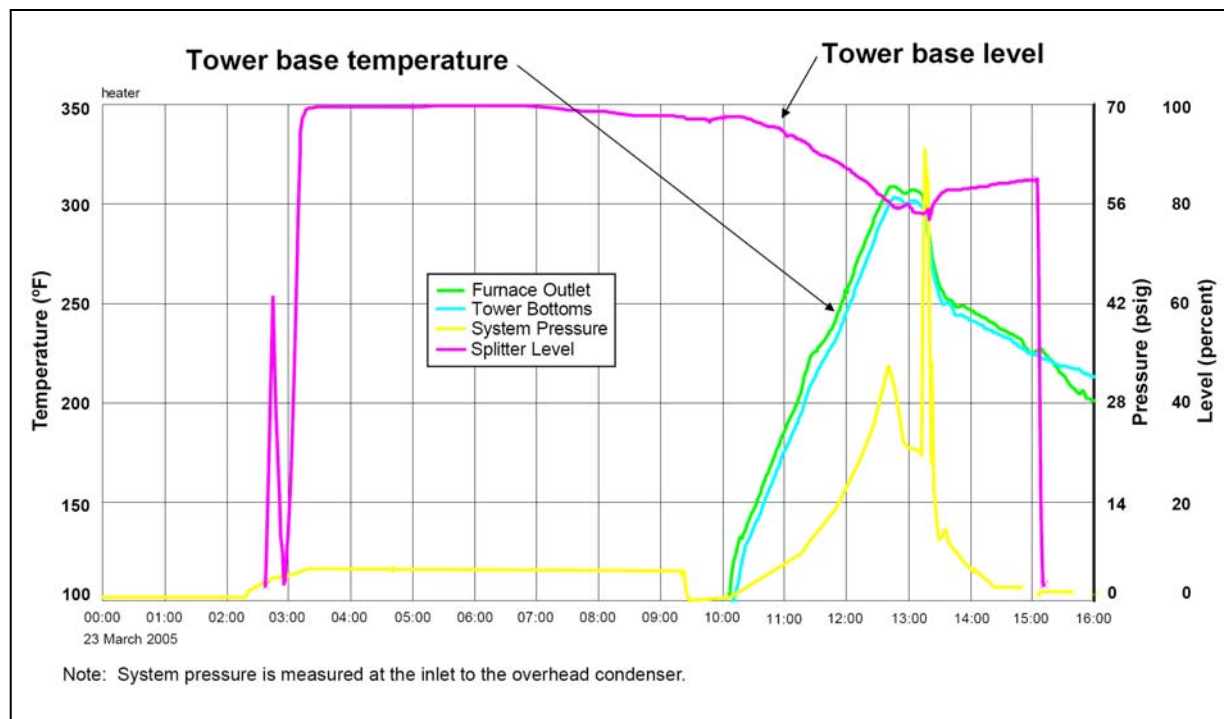
Figure 5-11
Indicated Tower Base Level as Temperature Increases

- Raffinate feed composition in the bottom of the Splitter due to lack of fractionation
- Calibration error or slightly different reference density
- Vaporization from the heater affecting base density (unlikely at the process temperatures)
- Dissolution of light-ends (nitrogen and methane from the feed drum) lowering the bulk density

The dissolution of light-ends could also explain that the level drift in the period of 07:00 to 09:00 hrs (when the column is isolated) could be due to a slow warming up of the vessel due to increasing ambient temperature.

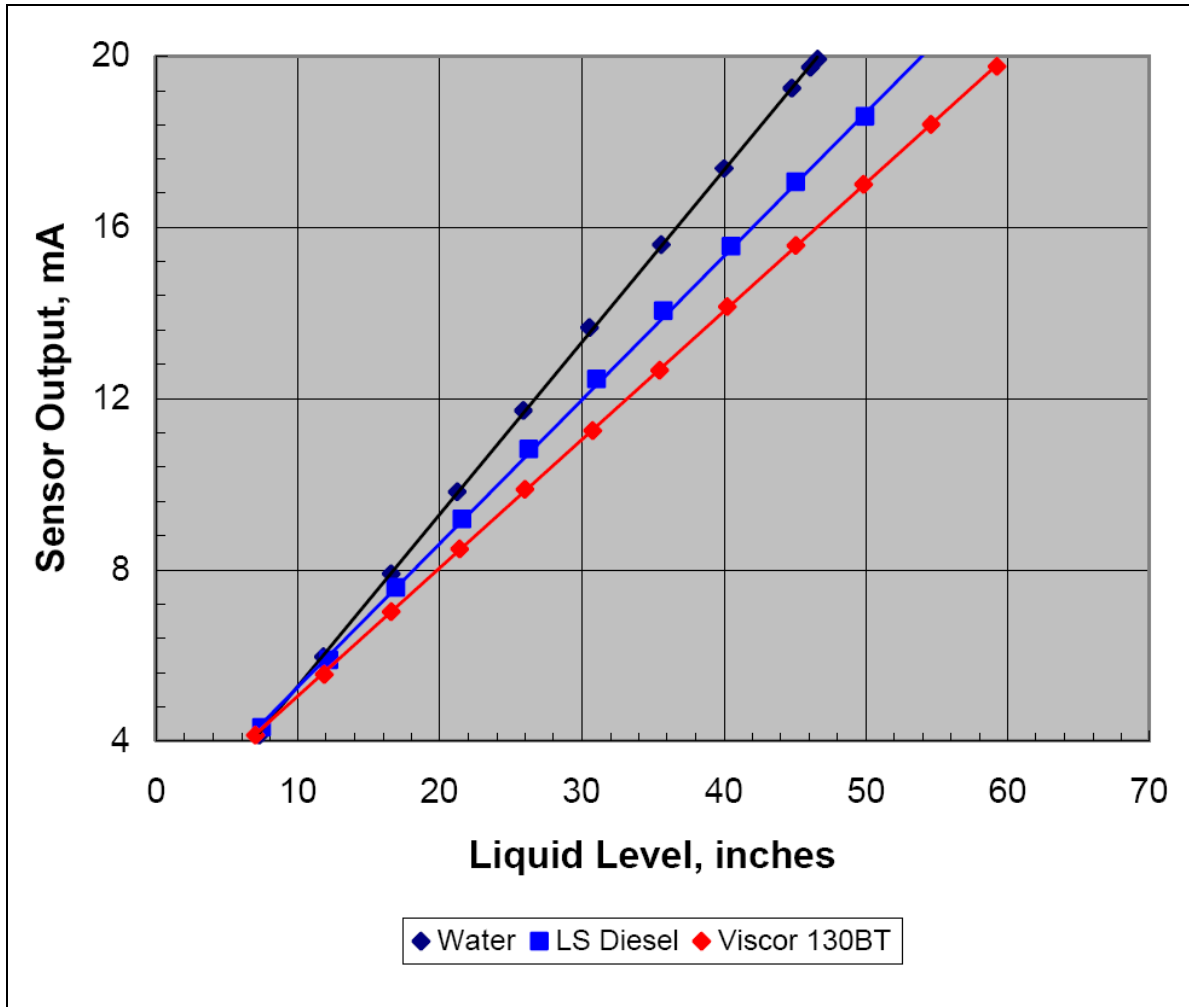
Figure 5-12
LT-5100 Tower Level Sensor Test

The raffinate splitter level transmitter LT-5100 was tested for function and linearity using liquids with three densities: water (density 1.0 g/cm³), low sulfur diesel fuel (density 0.8349 g/cm³ at 60°F), and Viscor leak detection fluid 130BT (density 0.7593 g/cm³ at 60°F). Highly linear relationships between liquid height and the level sensor output signal were obtained over the operating range with all three test fluids, see figure below. As expected, indicated level varied in proportion to fluid density. The local readout meter on the Rosemont transmitter functioned normally and gave linear responses between liquid heights and indicated level.
